# FLUITEC CONSULTATIVE SERVICES

## Fluid Failure Investigation

Petrochemical Plant  
Centrifugal Compressor

**Customer** Petrochemical Plant (Example Report 1)  
**Subject** Centrifugal Compressor Oil Failure  
**Principal Analyst** Fluitec SME  
**Date** January 20XX

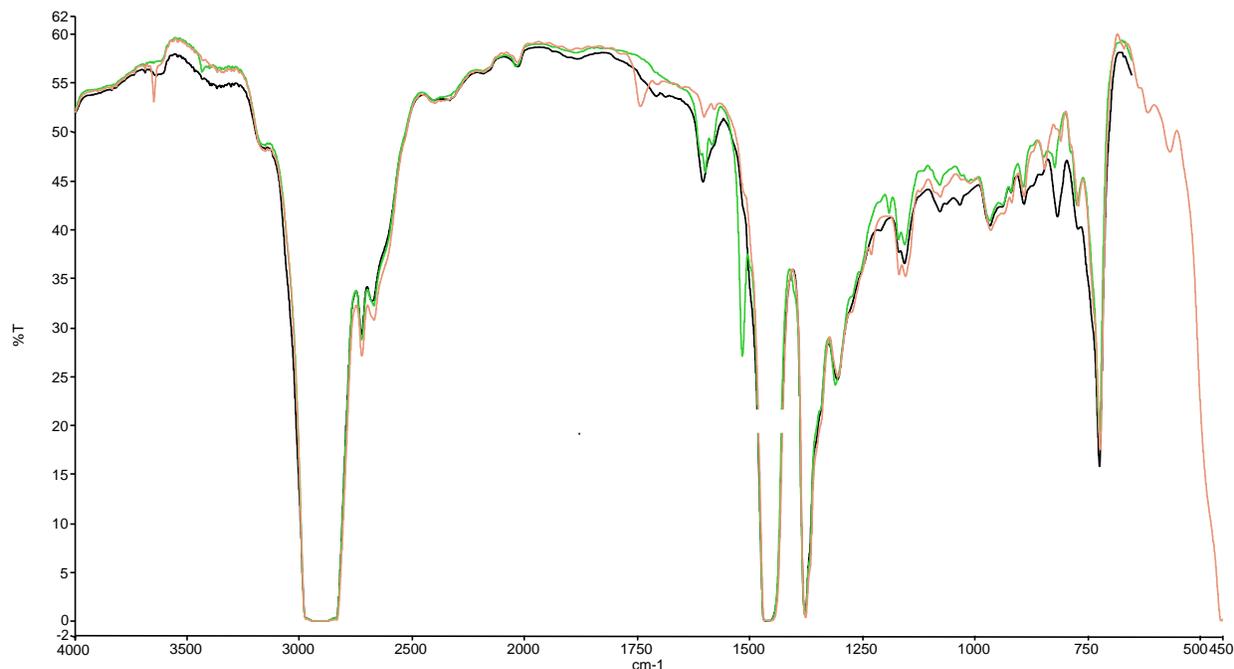
Fig.2 FTIR Spectra - In-service fluid compared against Brand Y and Z Fluids.

- The in-service fluid contains aromatic material at  $1600\text{ cm}^{-1}$ , indicating it is a Group I type base stock.
- There is no ester antifoam as seen in the Brand Y formulation.
- Degradation products exist at in the  $1700\text{ cm}^{-1}$  region – indicating oxidation has been occurring.
- The in-service fluid has a smaller aromatic amine content compared to the new Brand Z reference.

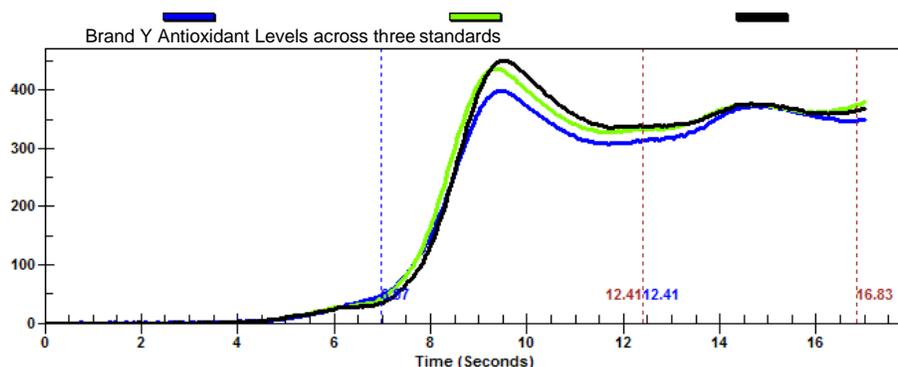
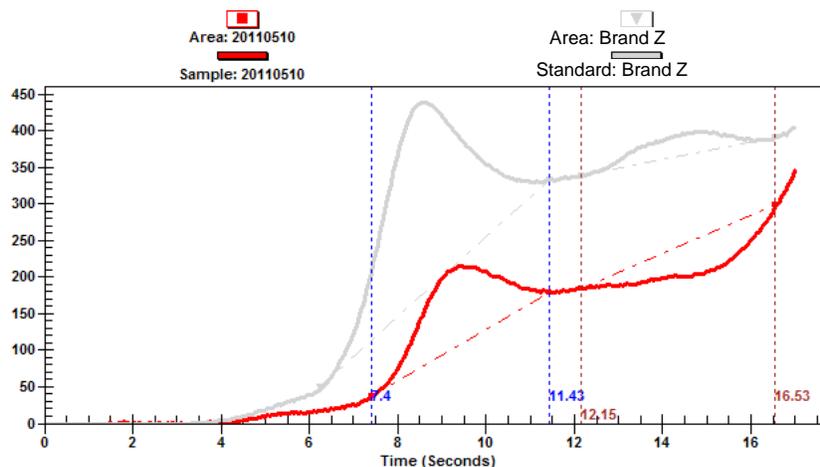
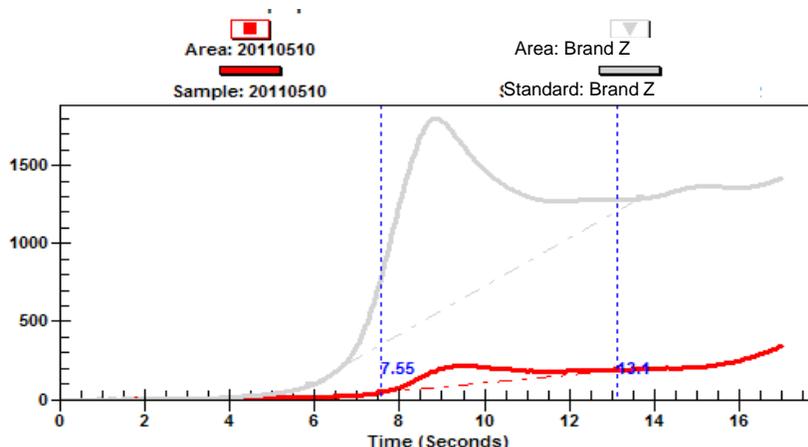
Table RULER Results

With reference to either comparison, the in-service fluid has serious antioxidant depletion. A fluid with antioxidant levels below 50% amine is often alarmed and signals that the fluid is at risk of oxidizing. The low level of antioxidants is consistent with the observation in the FTIR spectrum of oxidation materials being formed in the 1700 cm<sup>-1</sup> region, indicating that indeed the fluid is oxidizing at the current level of antioxidants.

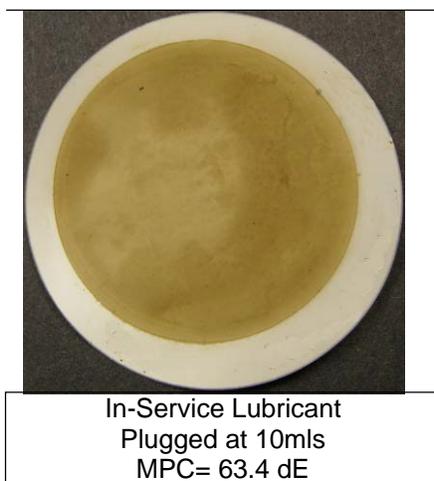
When this test was applied to this fluid, it plugged the filter with only 10 mls of the solution passing through the membrane. No more fluid would pass. This is an indication of critical level particles in the fluid. The varnish level on the patch (MCP = 63.4 dE) is also in what is considered as critical varnish potential.

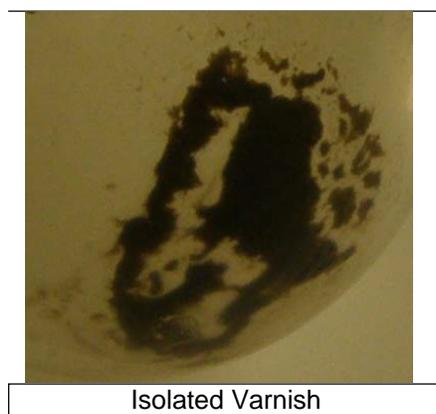
The isolated sample was then cleaned of the in-service fluid and submitted to characterization by FTIR spectroscopy. This procedure was developed to aid in root cause investigation studies. The picture below shows pictures of the varnish samples isolated from this unshaken sample.

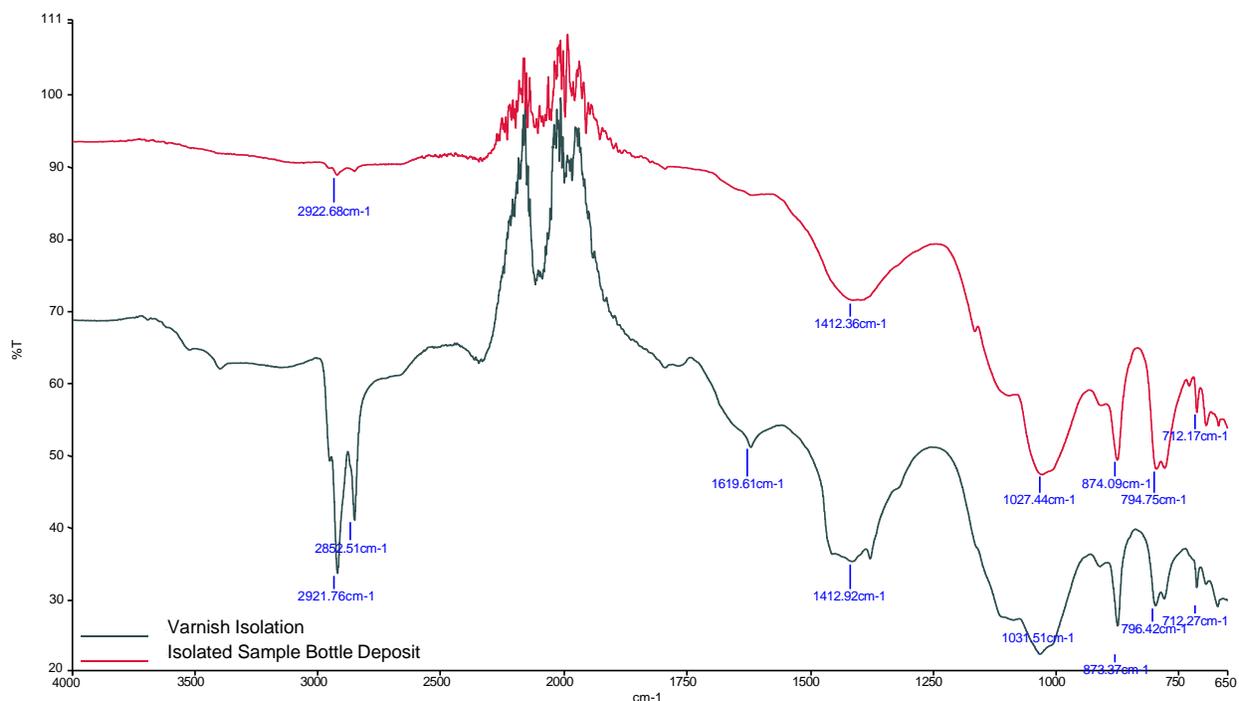
Fig. 6 FTIR spectra of isolated varnishes.

This figure shows that the two materials are very similar. The only difference is that the fluid varnish had a minor portion of some organics present. These organics can be defined as thermal-oxidative varnish by the presence of thermal-oxidative materials in the 1700-1600 cm<sup>-1</sup> region. This indicates one of the mechanisms of the organic varnish production is related to fluid over-heating in the equipment along with the low levels of antioxidant protection.

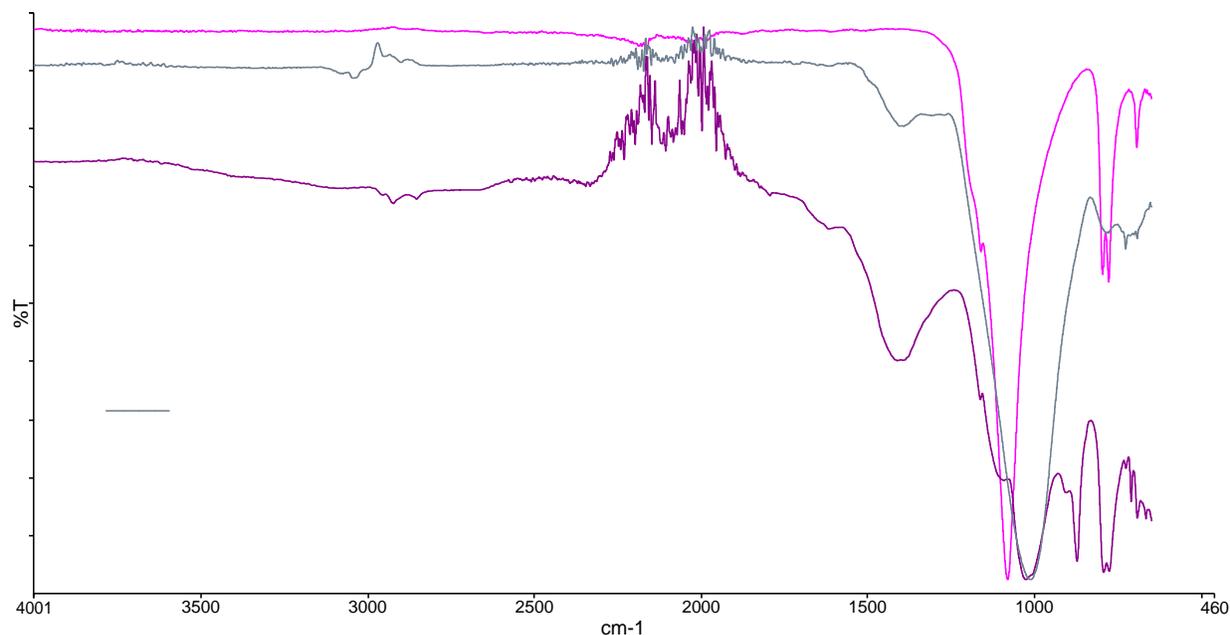
Fig. 7 FTIR spectra of isolated varnish compared against Silicates

This spectra comparison shows that the major portion of the varnish is silicate. Silicates can come from minerals ingress like silica, fuller's earth or sand. They can also come from waste-gas combustion products – which contain silicates and chloro-silicates. It should be noted that chloro-silicates will react with time to become the silicates observed. They also could cause the observed burning of the skin observed by the customer. One would not expect these chloro-silicates to still be present when the sample was received since their reactivity is too high. There is no evidence of chloro-silicates in the fluid or in the isolated varnish. Due to the “burning” observation however this source needs to be further investigated.

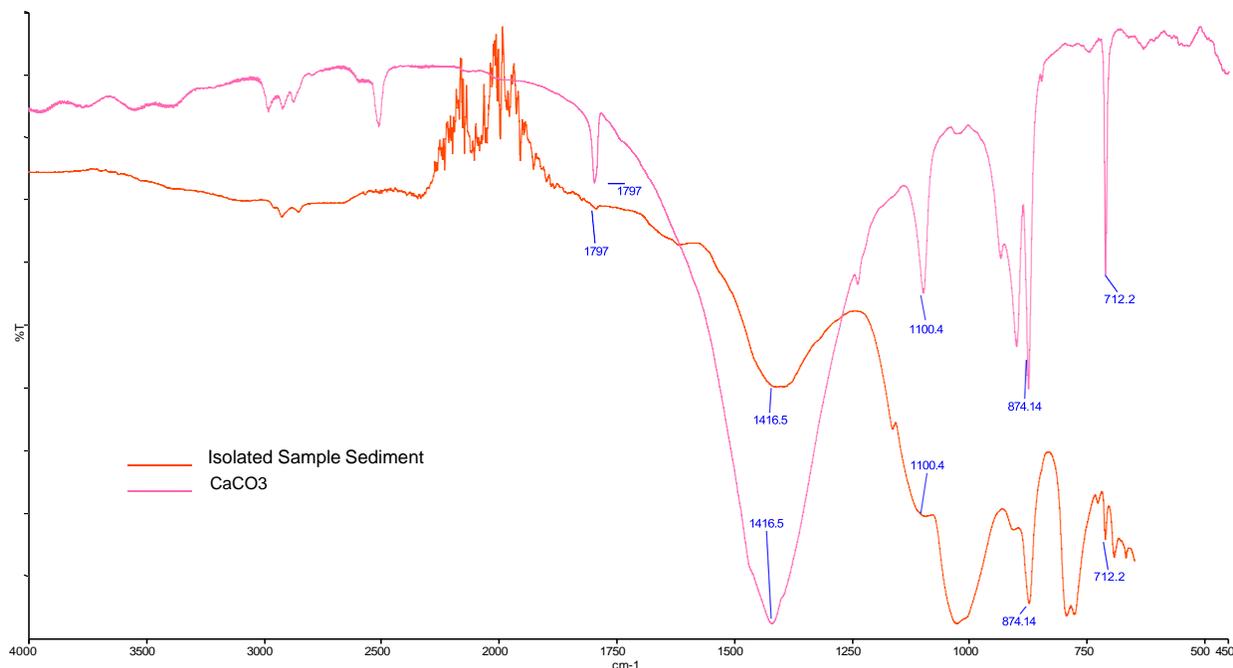
Fig. 8 FTIR spectra of isolated varnish compared against carbonate

Carbonates can come from the detergent packages (measured by TBN) of some crankcase fluids, CO<sub>2</sub> compressor gas ingress and minerals like calcite and bentonite. The fluid shows calcium, sodium and silicon which are the make-up of several of these minerals potential for the carbonates and silicates.
