# FLUITEC CONSULTATIVE SERVICES

## Fluid Failure Investigation

Power Plant  
Gas Turbine

**Customer** Power Plant (Example Report 2)  
**Subject** GE 6B Gas Turbine Filter Analyses  
**Principal Analyst** Fluitec SME  
**Date** January 20XX

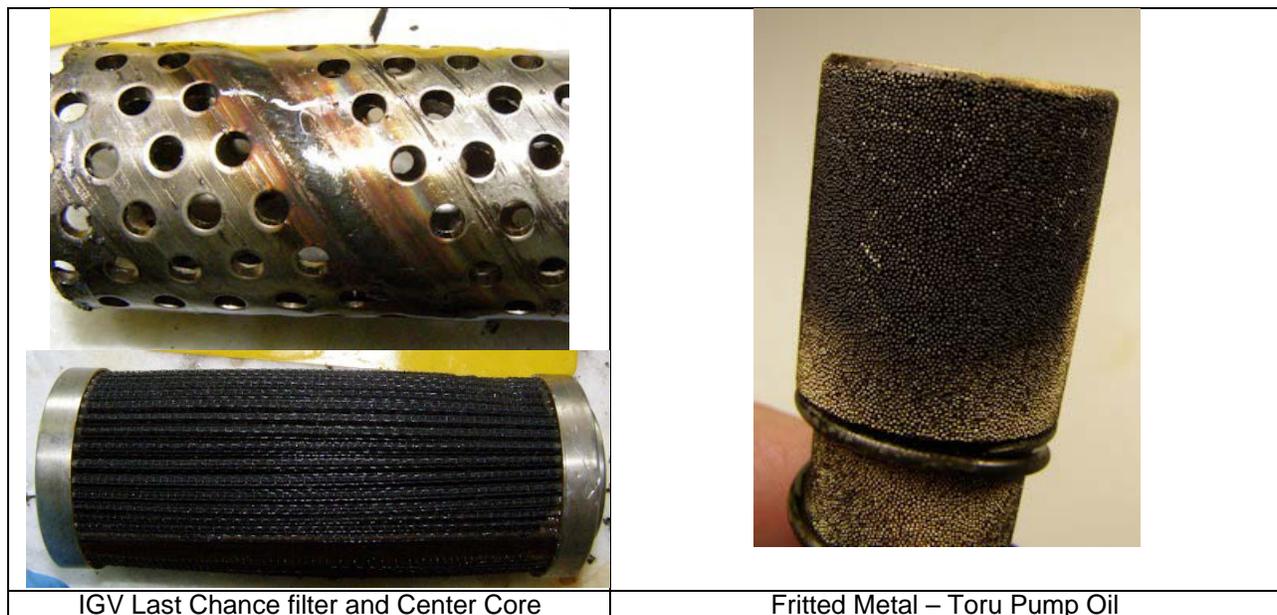
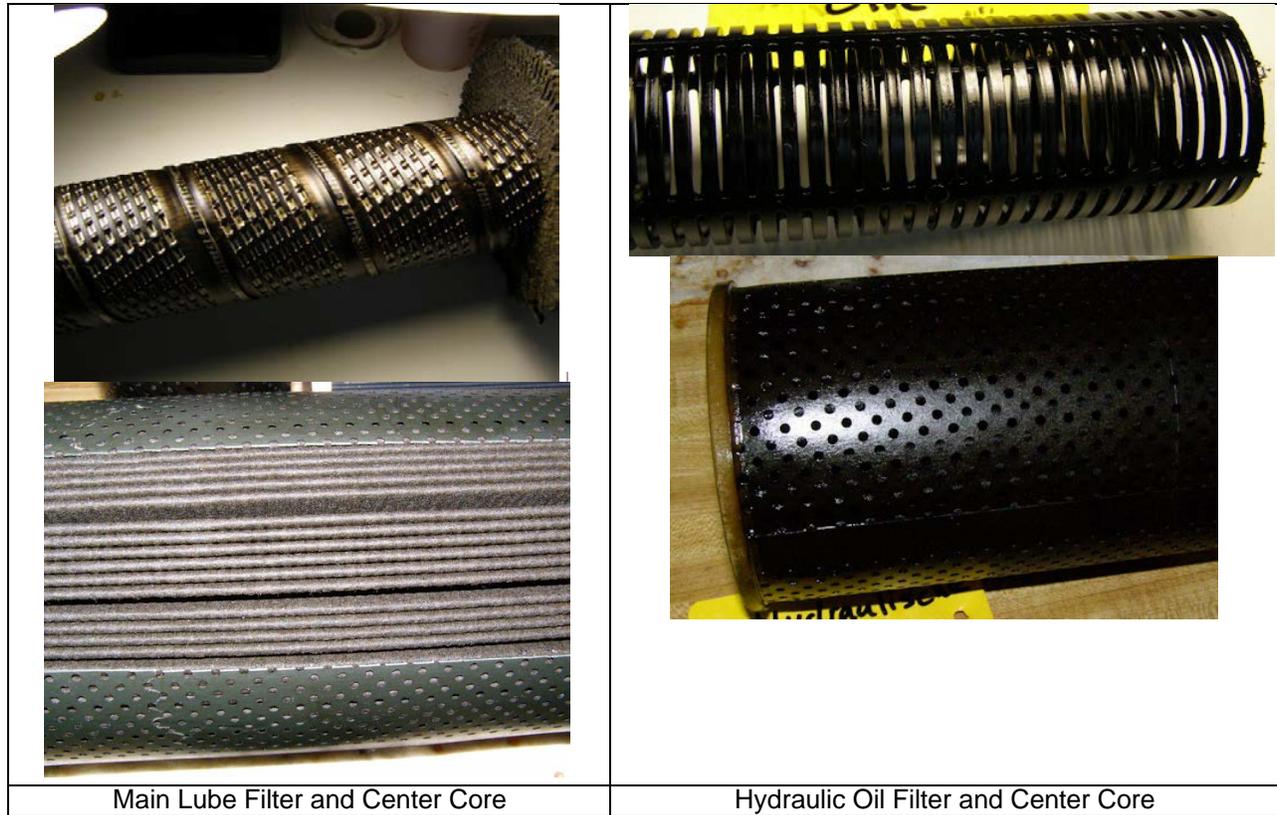
The center core of the hydraulic filter was a plastic material. As seen from the pictures above, this filter has varnish material throughout the filter. Although the center core was a black plastic material, one could still observe serious levels of varnish on it – as well as the filter material itself. Previous ESD studies have not revealed any evidence of spark damage to plastic filter cores. This filter was no exception as there was no evidence of ESD. The examination of the filter media also showed no evidence of ESD. It can be concluded that the hydraulic filter has not been experiencing observable ESD events. The filter was not affecting the varnish presence or level in the fluid – there were no measurable levels of varnish differences between outside or inside of the filter.

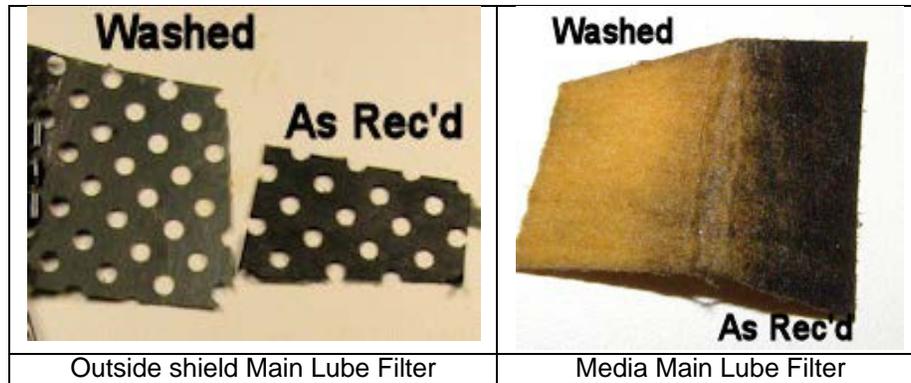
All the filters showed extensive varnish deposits – both inside as well as outside. As seen below for the Main Lube filter, this varnish was a brown coating on all the parts of the filter. Methylene chloride was successful in dissolving the varnish for removal.

The Main Lube filter had a crimped metal core design. It was dark brown coated with varnish, over a silver colored core. Studies of this core did not show any ESD evidence. Study for the outer shield and the filter media also showed no evidence of ESD events. Like the hydraulic filter, this filter had heavy varnish throughout. There were no measurable levels of varnish differences between outside or inside of the filter.

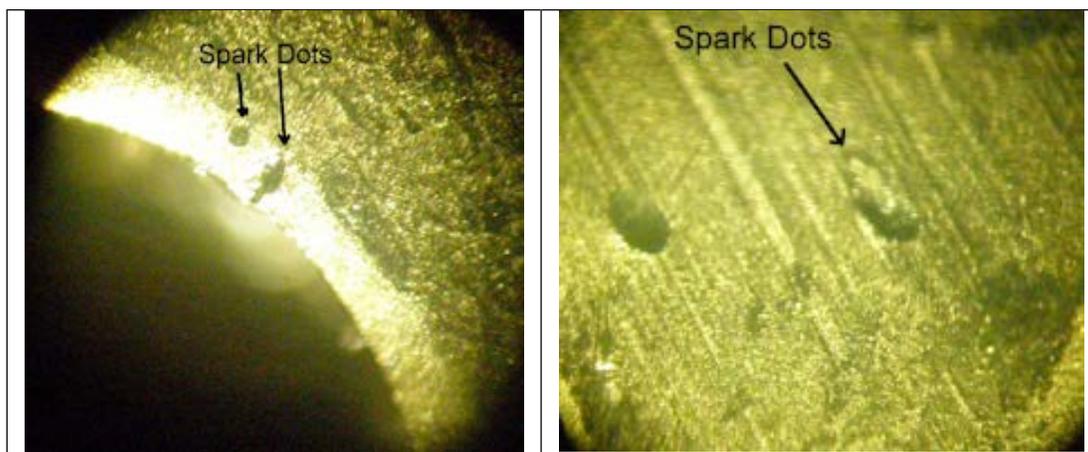
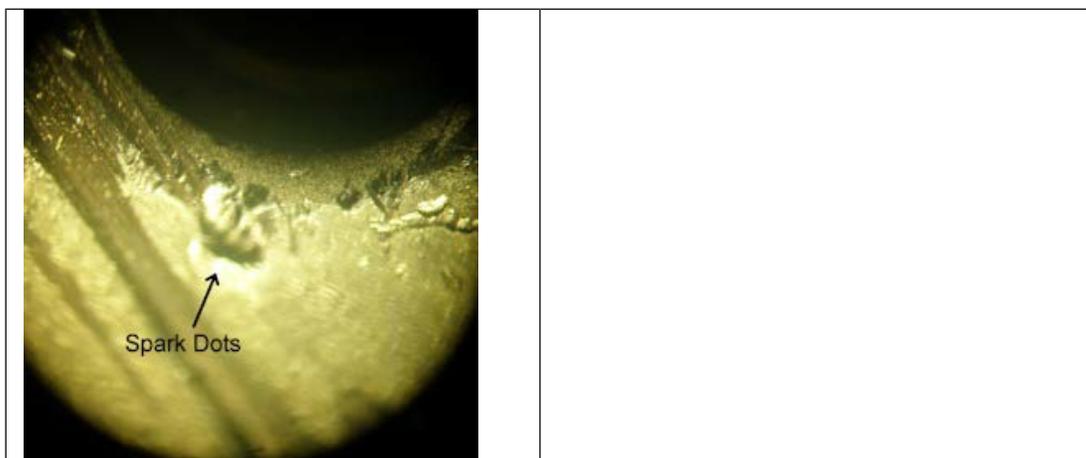
Like the other filter, the IGV last chance filter has varnish throughout. The level of varnish was not as heavy on this filter. The filter was studied for ESD by both examining the filter media and the center core. The filter media did not show ESD evidence. However, the center core did show ESD evidence.

The center core of this filter showed many small “spark dots” under microscope examination. These spark dots were the location that the spark contacted the metal core. They looked like a moon-creator where there was an indentation in the metal surrounded by melted metal. One can observe the visual differences of these spark dots from metal scrapes and dents in the above pictures.

There are multiple mitigation methods that we can suggest to eliminate ESD from occurring in your IGV last chance filter. In addition, we have suggested mitigation methods to manage PANA as it degrades and before it develops deposits in the system. Finally, when the oil is at the end of its useful life, we can provide guidance on using a better turbine oil that is free of PANA.

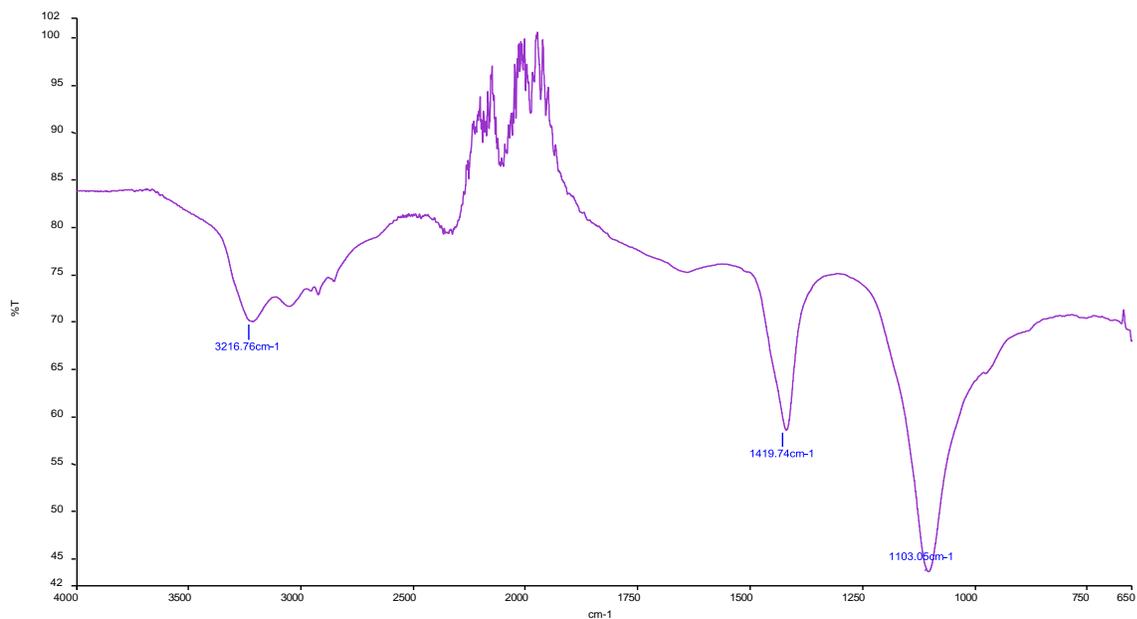
Fig. 1 FTIR Spectrum Inorganic varnish fraction.

The inorganic varnish showed three major FTIR peaks that identify the three chemistries present – water and hydroxides ( $3217\text{ cm}^{-1}$ ), silica ( $1103\text{ cm}^{-1}$ ) and carbonate ( $1419\text{ cm}^{-1}$ ). This chemistry is classic for the presence of dirt. The isolation of dirt from a filter is not uncommon, especially the Main Lube Filter.

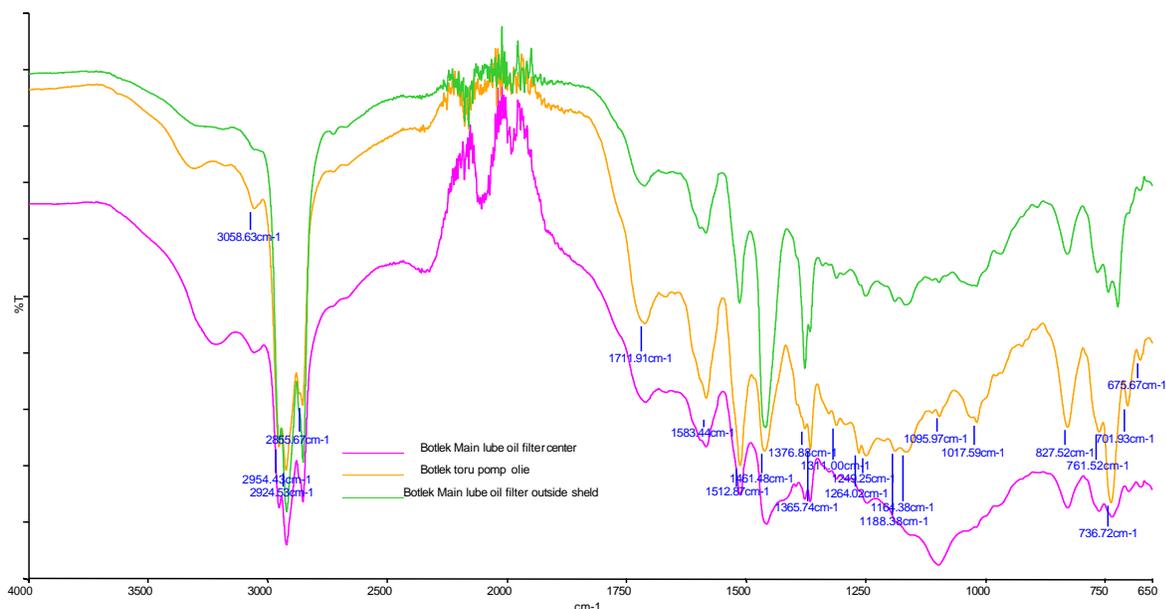
Fig. 2 FTIR Spectrum varnish fractions.

In addition to the inorganics observed ( $1103\text{ cm}^{-1}$ ) included in the Main Lube Filter Center sample, all the varnish samples taken showed the same chemistry. This chemistry included aromatics ( $3058, 1583, 1512, 830\text{-}720\text{ cm}^{-1}$ ) and carboxylic acid ( $1711$  and  $1188\text{ cm}^{-1}$ ).

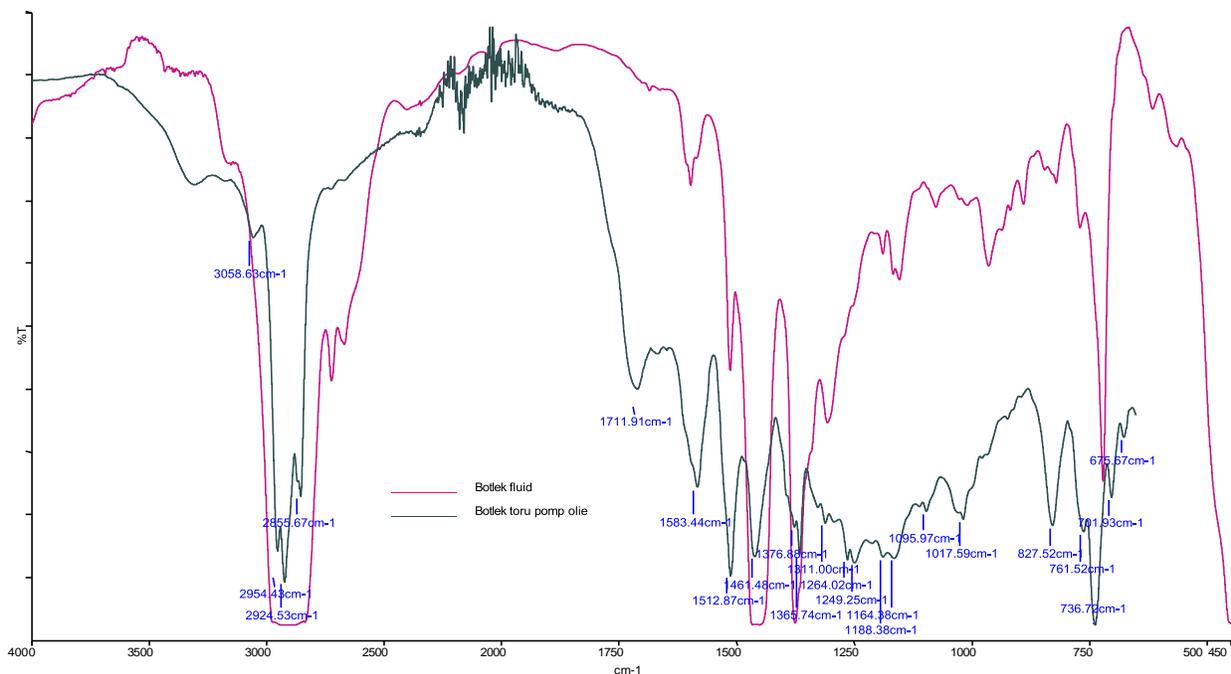
Fig. 3 FTIR Spectrum varnish and system fluid

The varnish isolated was first compared with the fluid that came with the filters (Fig. 3). One can observe the fluid contains some of the aromatics in common with the varnish samples. Knowing the formulation chemistry of this particular turbine oil and comparing this fluid with new oil, there are very little differences observed. The fluid is a Group I base stock (high aromatics) with an aromatic amine antioxidant. The in-service fluid shows a very small additional peak at  $1686\text{ cm}^{-1}$  that can be associated with some of the ESD observed on the filters. However, the varnish did not show this component – indicating the contributing effect of ESD to degrading the oil and causing varnish was small.

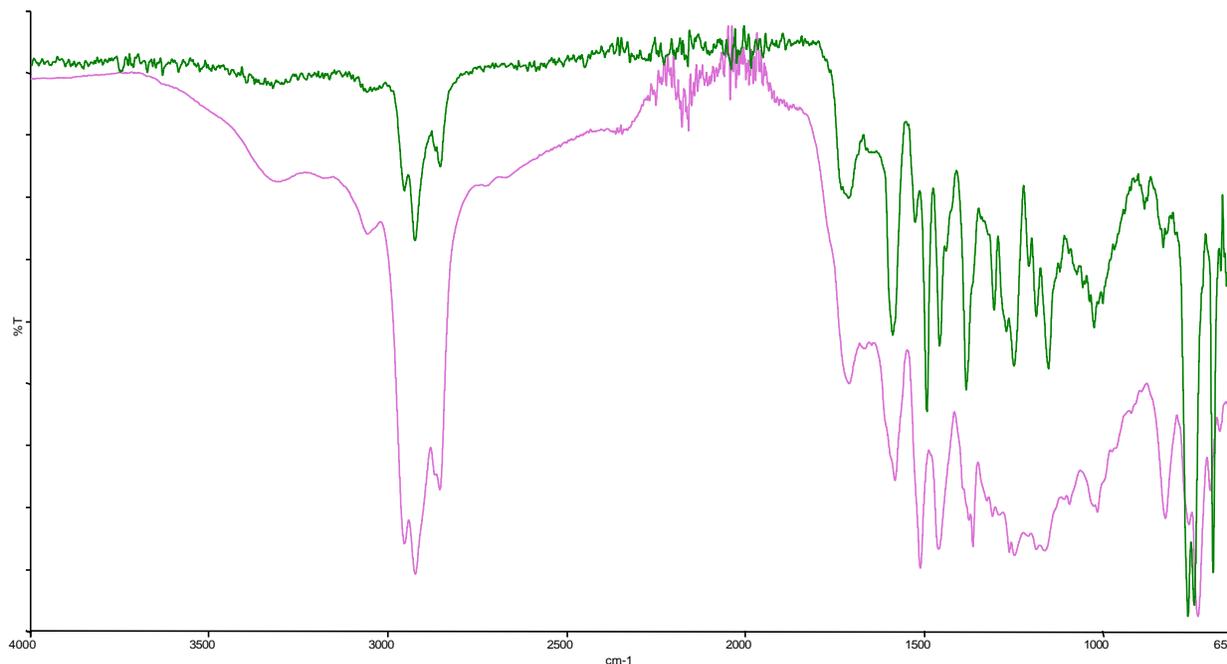
Fig. 4 FTIR Spectrum varnish and decomposed PANA.

Comparing the isolated varnish with other known/identified varnish samples (Fig. 4) shows that this varnish is related to the aromatic amine antioxidant formulated in the fluid – PANA.

PANA (phenyl alpha naphthyl amine) is known to decompose and produce a varnish component. The FTIR spectrum of the isolated varnish in this system shows that it is the same chemistry as that previously isolated and identified as the decomposition products of PANA.
