# Removing Varnish and Preventing Another Unexpected Outage

Fluitec's ESP helps remove oil degradation products

**APPLICATION:** Gas Turbine

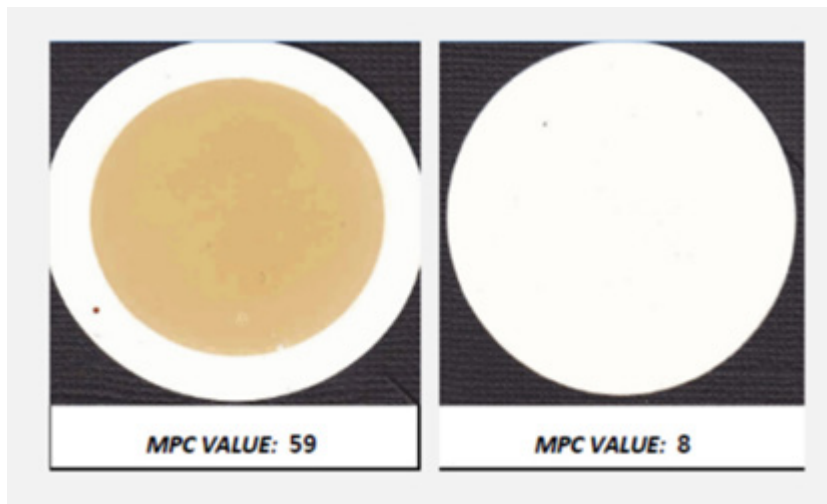
Inspection of the failed hydrogen seals showed significant mechanical damage as well as thick layers of Critical Varnish. Analysis of the oil also showed high varnish potential. The MPC values were 59.

**FIG. 1 -The Membrane Patch Colorimetry (MPC) test is run according to ASTM D7843. It measures the varnish potential of a turbine oil. Fluitec's ESP system was able to reduce the MPC value from 59 to 8, preventing another hydrogen seal failure due to varnish.**

Along with the installation of new hydrogen seals, the plant also installed Fluitec's ESP unit. The varnish potential of the oil was reduced from an MPC value of 59 to 8 in less than a month.
