# Extension of Oil Life and Increased Reliability at Waste to Energy Plant in Germany

**CLIENT:** Major Waste to Energy Plant

**APPLICATION:** Waste to Energy

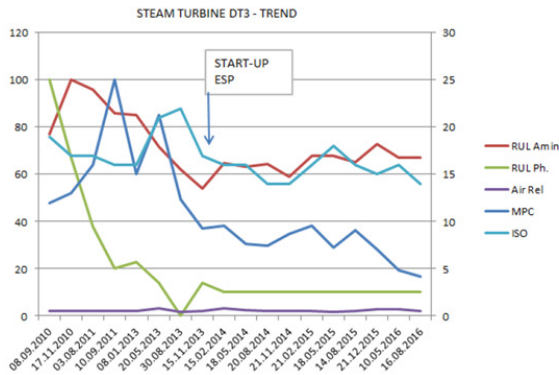
After installation of the ESP system on the first turbine, there was a decline in the MPC values from 58 to 11. Following the new oil change, the ESP unit remained in service on this turbine and the MPC values remained within the normal range (below 15) for the next three years. The ISO cleanliness levels were also maintained and fell between the ranges of 16/14/13 and 19/18/15.

Fig.6: MPC patch tests from MVA Hamm Turbine in 2011 (left) and after 1 year service (right)

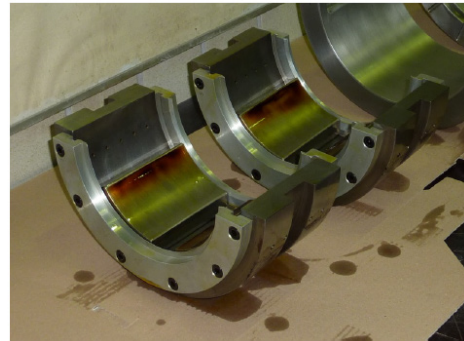
The servo valves on one of the turbines began experiencing issues with sticking and deposits were also seen on the valve internals and radial bearings. After these were noticed, the system was manually cleaned and returned to operation. One year after this manual clean-up, the oil analysis results showed a drastic increase in varnish type contamination and an accelerated decline in antioxidants (only 10% remained). Additionally, the air release values were nearing the OEM's condemning limit of 8 mins. The oil needed to be changed but the plant needed to ensure the varnish issues did not return.

Figure 2: varnish deposits on bearings at MVA HAMM Turbine 1

Fluitec's **ESP** was installed on the system three months prior to the oil change. The MPC levels went from 58 to 11 as the ESP cleaned up the entire system. The oil was then changed and the ESP unit put back into service. The MPC levels remained within the range of 5-6. As a result of this success, the ESP unit was then placed on another steam turbine with similar issues (elevated presence of varnish contaminants and depleted antioxidant levels). Comparable type results regarding the cleaning of the oil, restoration to OEM acceptable ISO cleanliness levels and reductions in temperatures

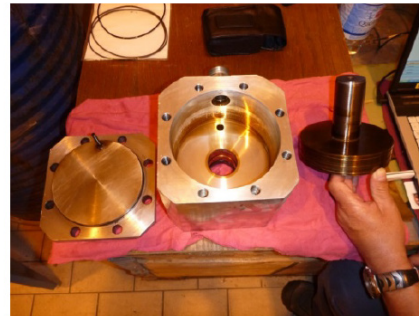
Figure 1: varnish deposits on servo valves at MVA HAMM Turbine 3
