## CASE STUDY

# ESP + BOOST VR: VARNISH IN TURBINE

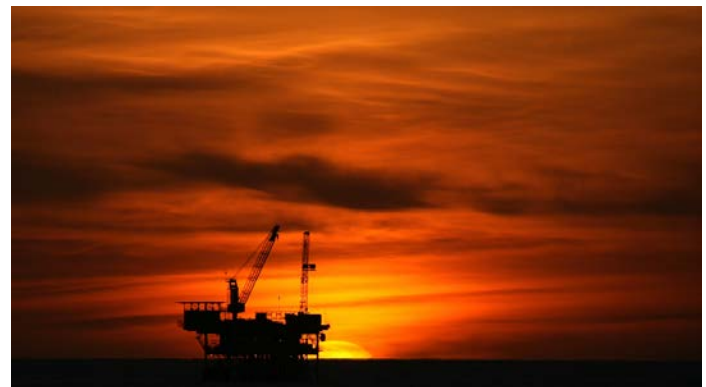
Back online, the thrust and journal bearing differential temperatures dropped 52 % to 14° C (57° F).

The customer installed Fluitec's ESP (Electrophysical Separation Process™) varnish mitigation system with Boost VR solubility enhancer to dissolve varnish.

ESP with Boost VR worked on the oil for three weeks during the turbine's cleaning process.

Boost VR dissolved the lubrication system's varnish while ESP removed the dissolved contaminants from the oil.
