# The Right Flush: Side-by-Side System Comparison

Fluitec's Boost VR+ reduces maintenance costs by 66% and labor hours by 92%

**CLIENT:** Power Generation

**APPLICATION:** Water Pumps

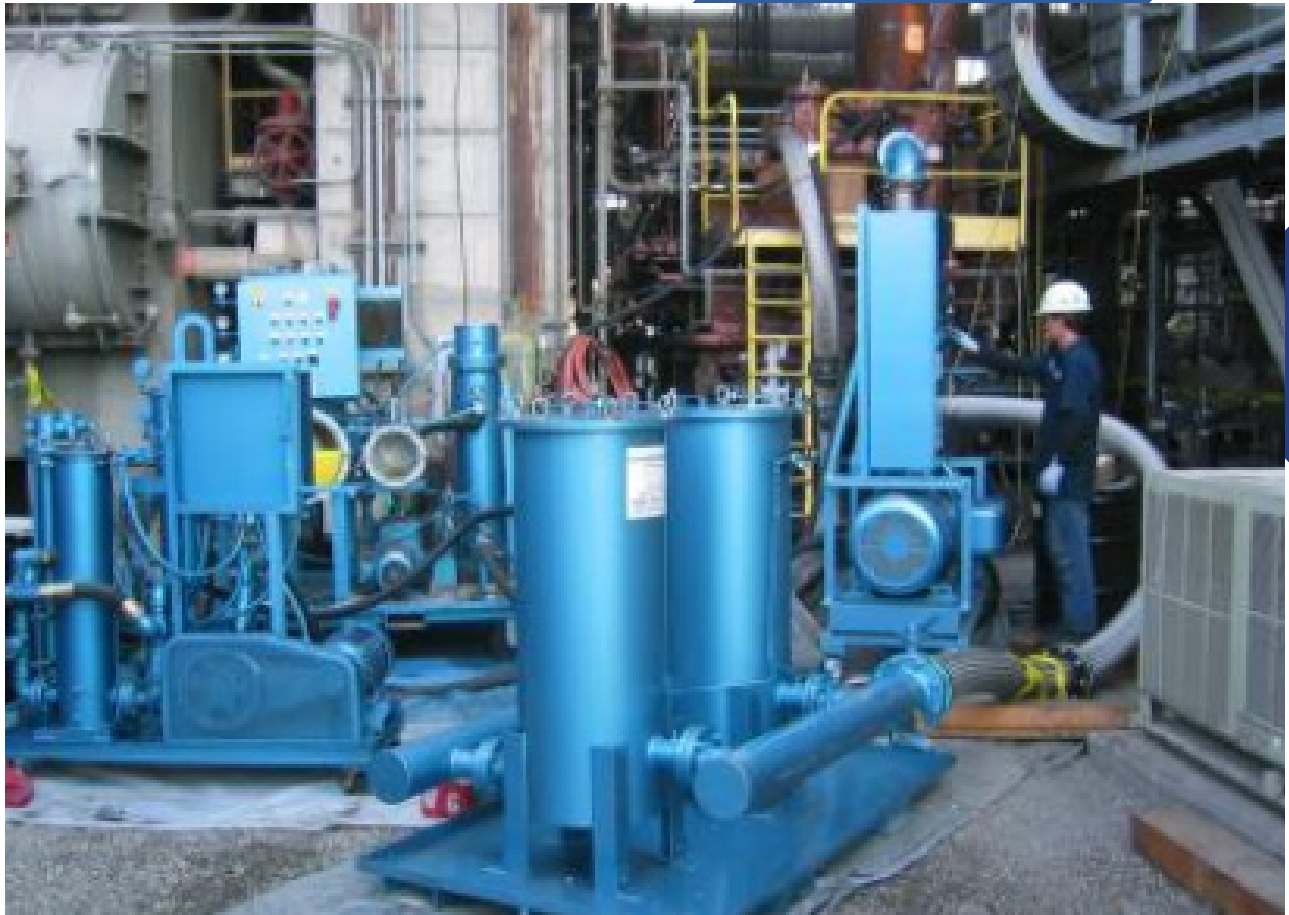
*Flushing rig set up to clean the system*

The services were outsourced to a professional flushing company which performed the services during a planned outage. The following procedures were followed:

- At the beginning of the outage, the lube system was drained and disposed
- Restrictive flow areas and critical components were isolated from the flush with the installation of specialized jumper hoses
- Confined Space Tank Cleaning was done on the reservoir
- A water-solution with a citrus cleaner was added to the system
- An external pump and bag filters were used to generate very high flow rates
- At the conclusion of the chemical flush, the water was removed from the system from draining and evaporation
- The oil system was charged with new oil.
- A high velocity, high temperature oil flush was performed to remove any other contaminants from the system

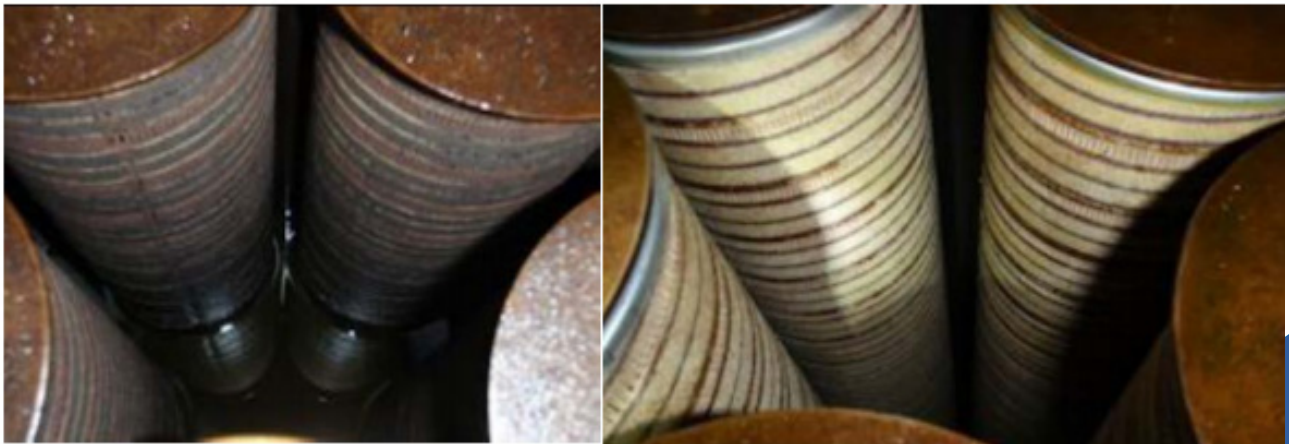
*The filters were significantly cleaned along with the other system components during the flush*

**Flush effectiveness:** All varnish and deposits were removed from the system. The flush was considered a success.
