Removal of Varnish Deposits at a Petrochemical Plant

Fluitec's ESP III and DECON help reduce high bearing temperatures and deposits

CLIENT: Petrochemical Plant

APPLICATION: Air compressor

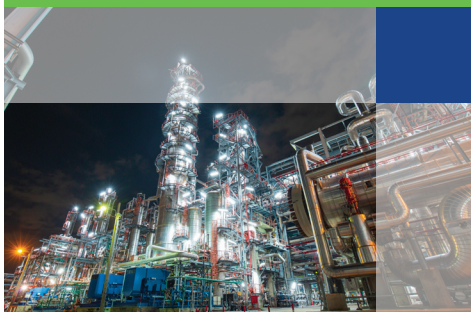
- MPC values normalized and after the first two months the values were within the range of 15.
- Within two years of the ESP unit being installed, the thrust bearing pads appeared clean and were free of any deposits.
- Bearing temperatures have also decreased drastically

Fluitec's **ESP** unit was installed on site
