case study

Optimizing maintenance costs and enhancing availability at a German power plant

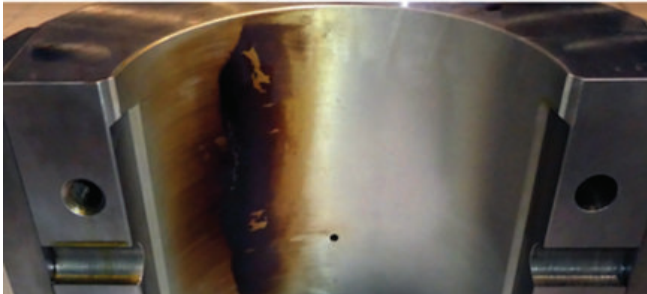
PINION BEARING BEFORE

In a major German power plant, signs of potential varnish in a turbine manifested as orange-brown deposits and increased foam formation. Heightened bearing temperatures were also noted in the pinion bearing. Despite MPC levels staying within the normal range, **RULER**® values showed a substantial decline in antioxidants, reaching threshold values alongside other critical indicators. The turbine oil was thus considered to have reached the termination point of its service life.

Introducing **DECON AO**™ at a 3% treat rate dissolved system varnish, replenishing critical antioxidants and eliminating the need for any necessary action for at least the next scheduled overhaul in five years. The Fluitec **ESP VITA II**™ system was also employed for oil cleanup, preceding the overhaul.

Fluitec ESP VITA II system facilitated comprehensive oil cleanup during the overhaul, enabling a deposit-free inspection of the pinion bearing. A subsequent treatment of DECON AO was applied, and the ESP system now sustains perpetual oil cleanliness, eliminating the necessity for oil replacement in two instances. This led to the preservation of 17,000 liters of new oil and associated replacement expenses.
