case study

Increasing productivity and extending oil life for gas turbines in a power plant in Australia

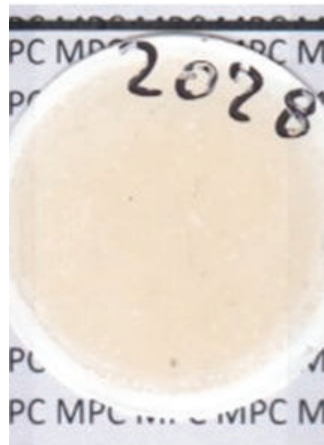
GAS TURBINE 1

BEFORE
MPC: 15

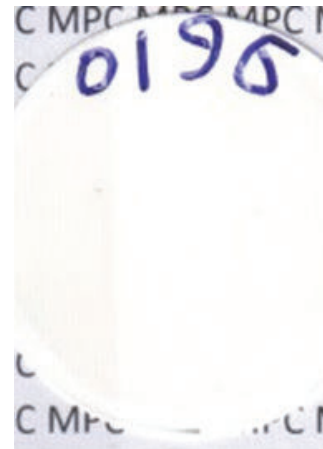
AFTER DECON
MPC: 2

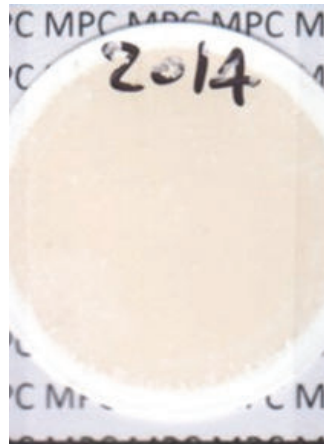
GAS TURBINE 2

BEFORE
MPC: 11

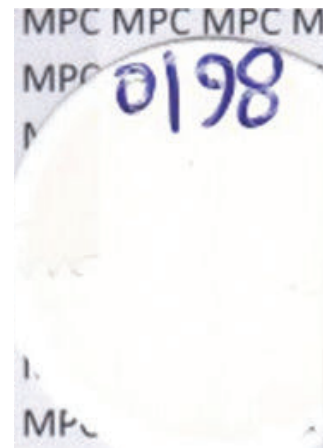
AFTER DECON
MPC: 1

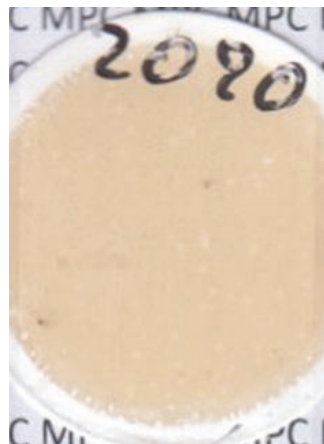
GAS TURBINE 3

BEFORE
MPC: 26

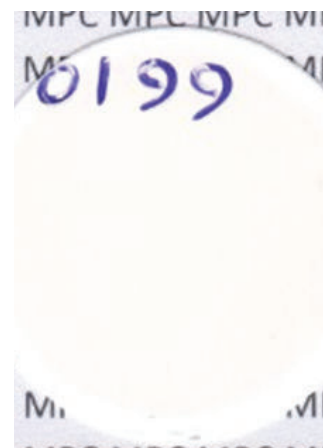
AFTER DECON
MPC: 3
