Fluitec Case Study

Germany | Paper & Packaging Manufacturer

Client:	Major Paper & Packaging Manufacturer
Country:	Germany
Application:	Steam turbine gearbox
Estimated ROI:	639%
Solution:	BOOST AO™ & VITA™ ESP

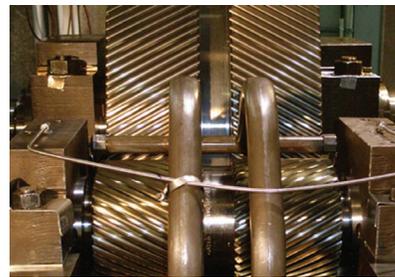
Gearbox AFTER treatment with Fluitec products

Fluitec's Boost AO was added to the gearbox and the Legacy ESP unit was installed. Within one year of installation and multiple filter changes, the oil was cleaned up and the unit did not experience any downtime.

After the installation of the Legacy ESP & addition of Boost AO to the gearbox, there was a significant decrease in MPC levels from 38 to a maintained level of 12. The ISO cleanliness rate also greatly improved from 23/20/13 to 18/15/14 & 15/14/12. The system did not experience any unplanned downtime and the plant was able to successfully deliver its products to all of its customers.
