Global Plastic Manufacturer Increases Productivity and Reduces Maintenance Man-hours

CLIENT: Plastic Manufacturer

APPLICATION: Injection Molding Machine

SOLUTION: Fluitec DECON

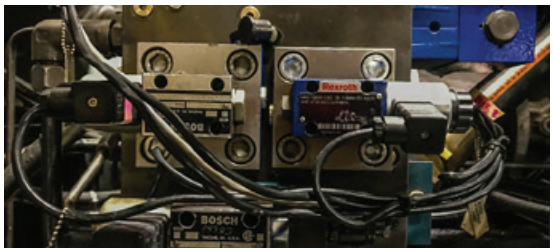
Their heat exchanger was plugged, allowing the oil to operate at 140F (60C).

The internals of the system were coated with brown, sticky varnish.

DECON was added to the reservoir during operation to solubilize the varnish, decontaminate the system and prevent further deposits from forming.

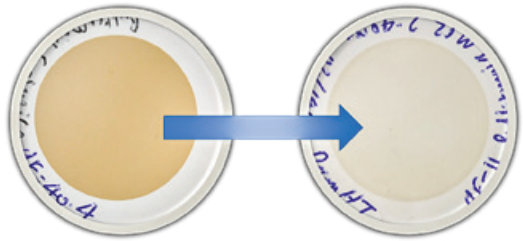
Within 2.5 hours, the Membrane Patch Colorimetry (MPC) results had dropped from 40 to 11. Within 24-hours, the heat exchanger started working. Oil reservoir dropped from 140F (60C) to below 100F (37C). Based on Arrhenius rate equation, this lower temperature translates to >4X oil life and significantly less thermal stress on the fluid. Their mornings now are easy and relaxed. The machine starts up instantly and no servo-valves have been replaced. Inspection of machine components and system internals reveal no deposits.
