# FLUITEC CONSULTATIVE SERVICES

## Fluid Failure Investigation

Petrochemical Plant  
Centrifugal Compressor

**Customer** Petrochemical Plant (Example Report 1)  
**Subject** Centrifugal Compressor Oil Failure  
**Principal Analyst** Fluitec SME  
**Date** January 20XX

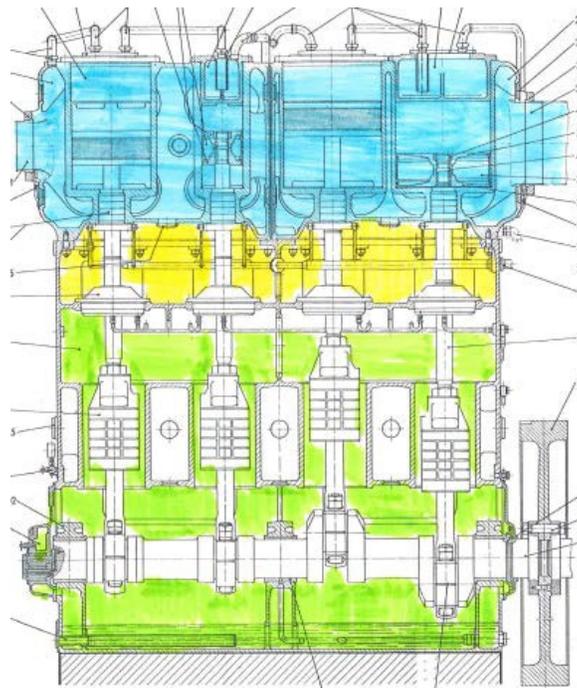
Fig. 1 Operational system Design

In-service fluids were submitted for study to better understand the fluid's failure causes and determine how the reliability of the system could be improved. There was a comment about the fluid "burning" the skin when first taken from the sump. The fluid came from a swing compressor that operates between  $N_2$  and  $O_2$ . It was a Centrifugal Compressor, operating with an axial and process screw. There is a distance between the process gas section and the fluid sump that is exposed to the air. This operation is to keep the fluid separate from the working gas.
