# Removing Varnish and Preventing Another Unexpected Outage

Fluitec's ESP helps remove oil degradation products

**APPLICATION:** Gas Turbine

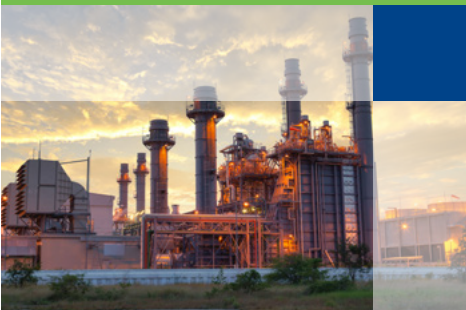
Inspection of the failed hydrogen seals showed significant mechanical damage as well as thick layers of Critical Varnish. Analysis of the oil also showed high varnish potential. The MPC values were 59.

- Reduce MPC from 59 to 8 in 30 days
- Removed Varnish from hydrogen seals
- Prevented further shutdown

Along with the installation of new hydrogen seals, the plant also installed Fluitec's ESP unit. The varnish potential of the oil was reduced from an MPC value of 59 to 8 in less than a month.
