WHITE PAPER

Innovative Solutions to Address Lube Varnish in Hydrogen Seals

BY GREG LIVINGSTONE, JON PRESCOTT & DAVE WOOTON OF FLUITEC

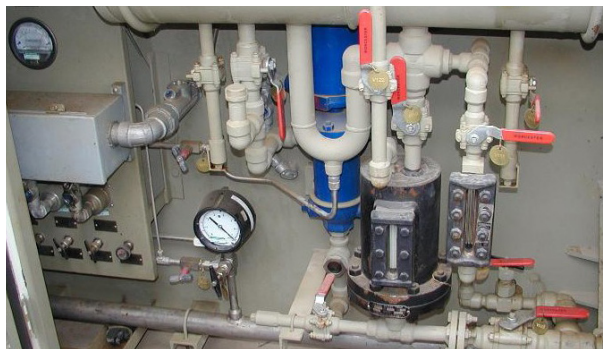
Fig. 1 - Controls for a hydrogen seal system in a large frame gas turbine.

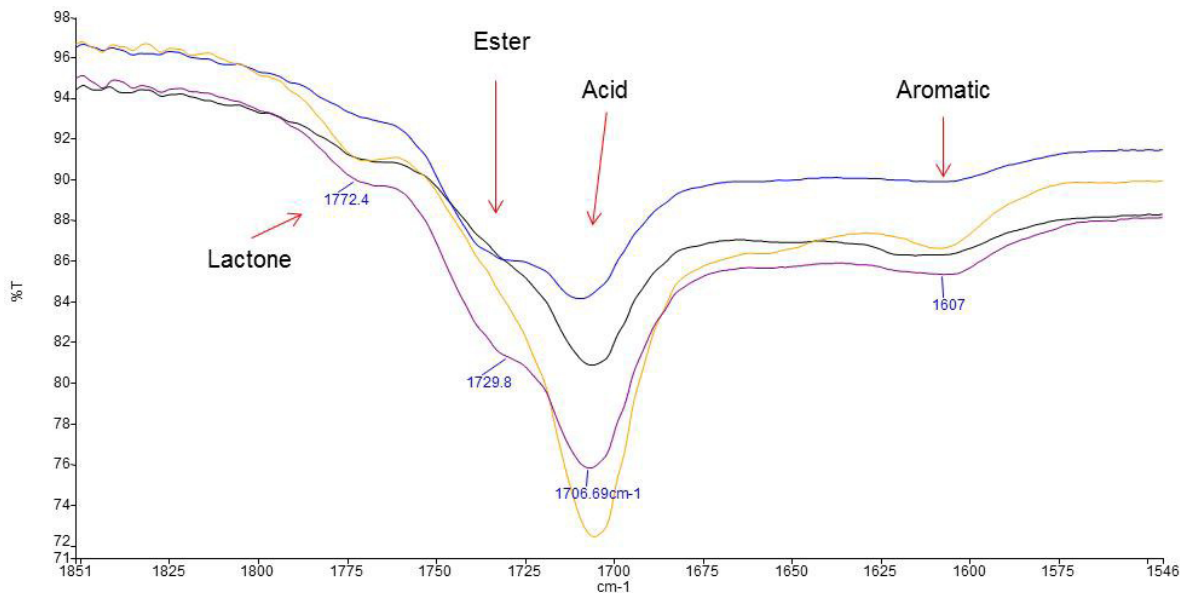
Fig. 3 - This Fourier Transform Infrared (FTIR) spectral analysis is of four isolated varnish deposits from hydrogen seals that are in the Incipient Varnish stage. This is a close up of the carbonyl and aromatic hydrocarbon region showing a molecular fingerprint of the degradation products found in the deposits. These degradation products are largely the result of oxidation mechanisms of the oil due to the formation of acids, esters and lactones.

Varnish deposits have been shown to have a wide range of chemistries and the typical chemistry of the Incipient Varnish in hydrogen seals can also be determined to have differences.

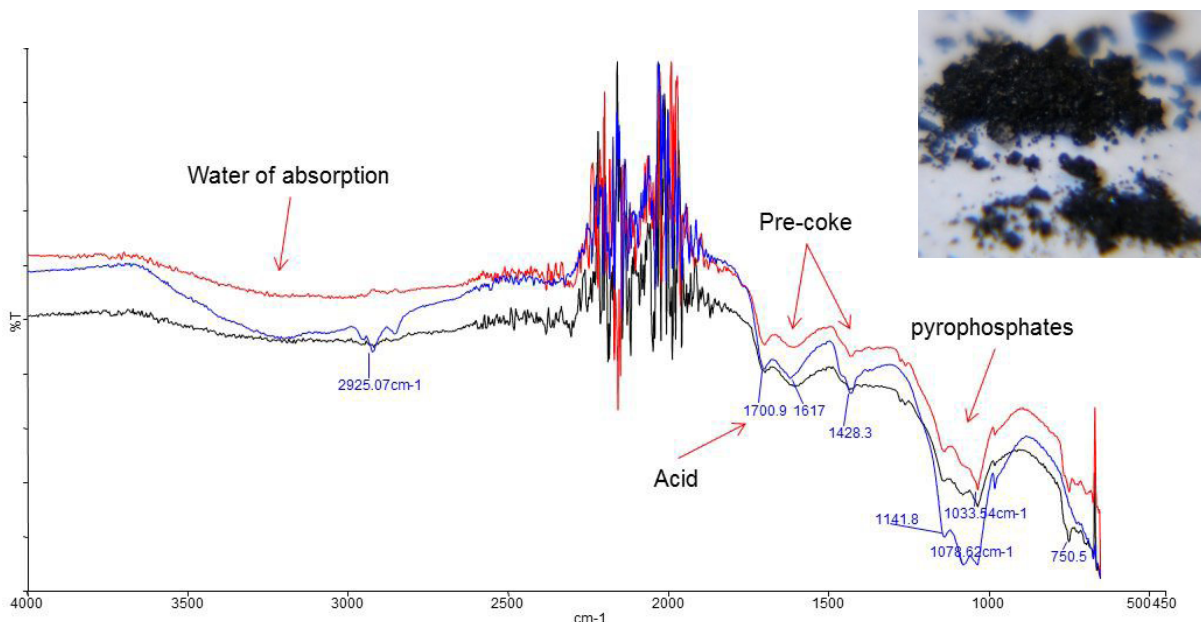
Fig. 5 –Varnishes are isolated into organic and inorganic fractions for proper characterization. This FTIR Analysis is of the inorganic fractions of Propagating Varnish. Often, Propagating Varnish started off as Incipient Varnish deposits composed primarily of oxidation products. Over time, and with excessive heat, these deposits further oxidize, dehydrate and transition to a dark colored pre-coke or black coke-like product as the temperature causes thermal-cracking of the varnish.

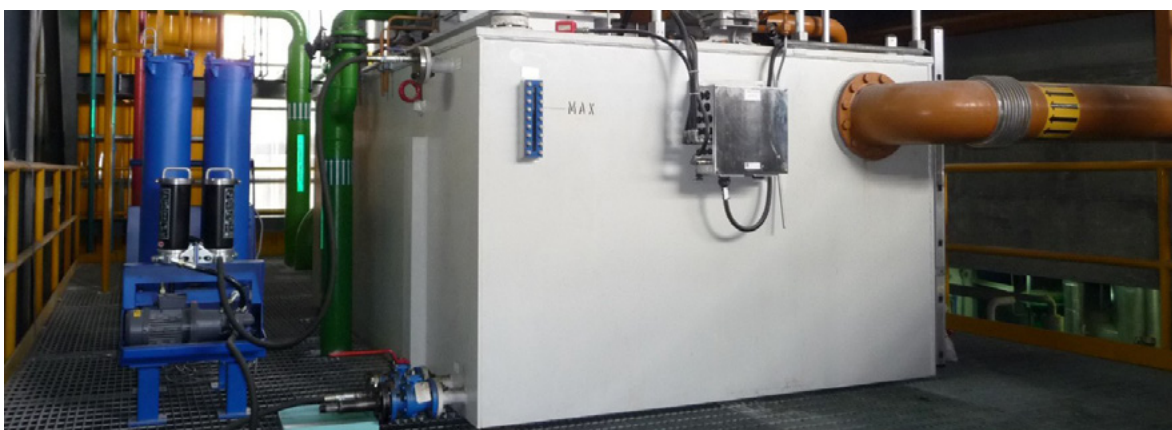
Fig. 7 – Fluitec ESP Varnish Mitigation System installed on a turbine.

Electrophysical Separation Process (ESP) – Fluitec's ESP is a kidney loop filtration system employing a unique chemical filtration technology that selectively removes oil degradation products without disturbing healthy additive components.
