Increase Turbine Efficiency and Solve Hydrogen Seal Varnish Issues

Fluitec's Boost VR+ helps increase fluid solubility

CLIENT: Power Generation

APPLICATION: Steam Turbine

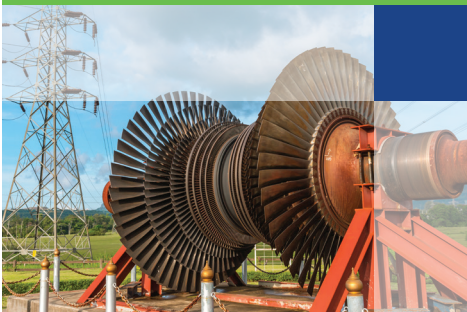
RESULTS

- Removed varnish from seals
- Increased turbine efficiency
- Increased oil and seal life
- Returned flow rates to normal operating conditions
- Reduced seal and oil temperatures by over 15°C

Six months after the installation of the new seals, flow rates dropped and the same problem re-emerged. The plant inspected the seals and found Incipient Varnish covering the surfaces.

Before switching back to the older spring seal design, the plant decided to use Boost VR+ to increase the solubility of the oil for a positive impact on the varnish deposits. One week after the introduction of Boost VR+, the flow rates improved. The plant had the ability to inspect the seals one month later and found the seals to be clean and the layer of varnish removed.
