# WESTO GETS HYDRAULIC AND TURBINE OILS BACK INTO SHAPE

#### Stadtwerke München: 8,500 l of turbine oil: varnish removed and a saving of two oil changes

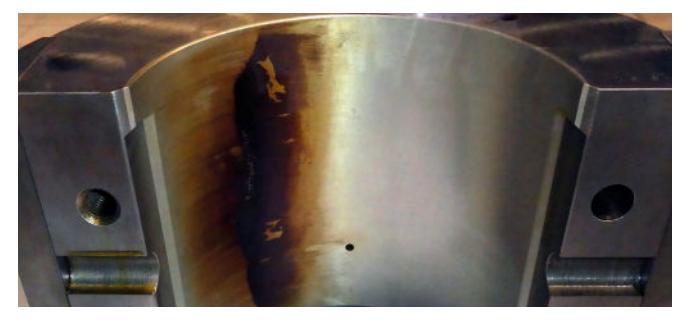
View into a pinion bearing: Before ...

... and after the varnish treatment.

and mechanical cleaning of the pinion bearing, FLUITEC Decon AO is added again as a precaution in order to protect the oil from a recurrence of the tendency to form varnish.

OELCHECK then meticulously examines the turbine oil. The result: All parameters leave nothing to be desired! The turbine oil is back in shape! – The bearings of the steam turbine are also inspected as part of the overhaul. They are clean and free of deposits. Only the cooler of the system needs to be chemically cleaned of stubborn deposits.

doesn't look good at first. Worryingly high temperatures are detected on the bearings of a pinion bearing. Do the 8,500 l of turbine oil now have to be finally replaced with fresh oil? During ongoing operation and even before the turbine overhaul, WESTO uses a filter system in the bypass flow that works in a completely differently way to the classic bypass filtration. Both suspended and dissolved deposits need to be eliminated from the oil in order to eliminate the risk of varnishing. No typical off-line filter system can handle this, as many of the particles are usually under 0.1 µm in size and are therefore too fine to be captured. - WESTO is convinced that only a cleaning that makes use of the FLUITEC ESP procedure can handle this task. It works by accumulating the oil reaction products on special resins and removes both suspended and dissolved oil reaction products, even at the operating temperature
