Solving rapid filter fouling and high varnish for a refinery in Poland

Client:	Major Refinery Company
Country:	Poland
Application:	GE Frame 9F Gas Turbine
Cost savings:	€392,000 over 5 years
Oil savings:	50,000 liters (sump size)
CO2e kg saved:	361,071 CO2e kg over 5 years
Solution:	DECON

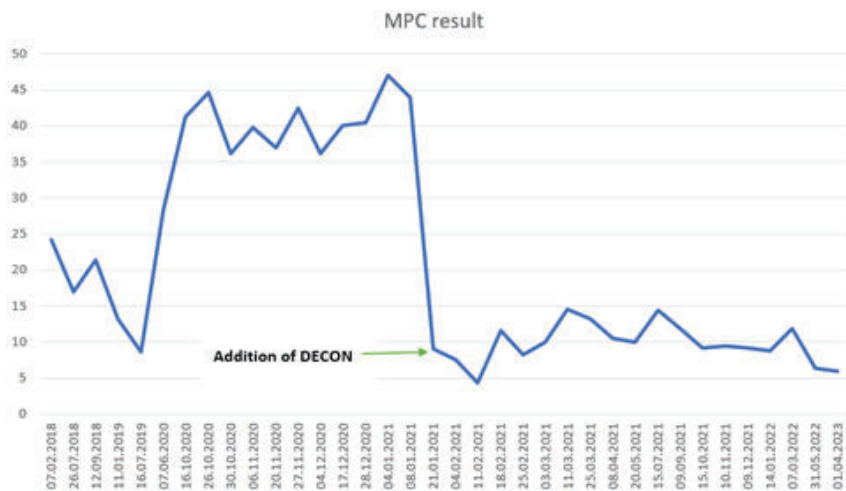
Following the addition of DECON, MPC levels have consistently remained below 10. Simultaneously, the previously increasing filter differential pressures were stabilized. Other essential oil properties, including viscosity, oxidation stability, foaming

tendency, and air release, remained within acceptable parameters. This facilitated prolonged utilization of the turbine oil, eliminating the need for a flush and recharge operation.

Fluitec's partners assessed the existing conditions and decided to add **DECON™** at a treat rate of 3%. This should decontaminate the system and aid in reducing the constantly increasing differential pressures.
