# Fluitec Case Study

# Qatar | Major Oil & Gas Company

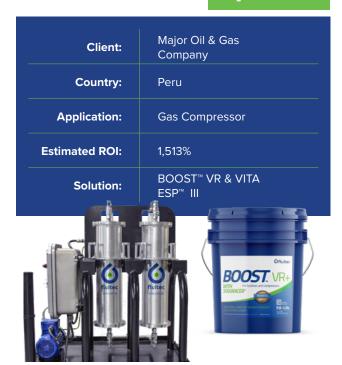
- MPC dropped to very low levels within 4 days; remained within acceptable limits over the following three months, enabling a clean oil upgrade without cross-contamination.
- Nine months after the upgrade, all lube oil parameters, including MPC, remained within acceptable limits.

A Vita ESP (Electrophysical Separation Process) III unit was connected to the reservoir to remove degradation products. Boost VR was added to increase oil solubility and mitigate varnish. The treatment was performed  $^{\prime\prime}3$  months prior to the oil upgrade, with no machine shutdown.
